Community Report ‘Atal Ayub Nagar’

Satellite maps and description of the water supply in Atal Ayub Nagar with collated chemical test analysis data and new test results.

**Qualitative description of the water supply among communities surrounding the
former Union Carbide India Limited (UCIL) pesticide plant in Bhopal**

Focus on Atal Ayub Nagar

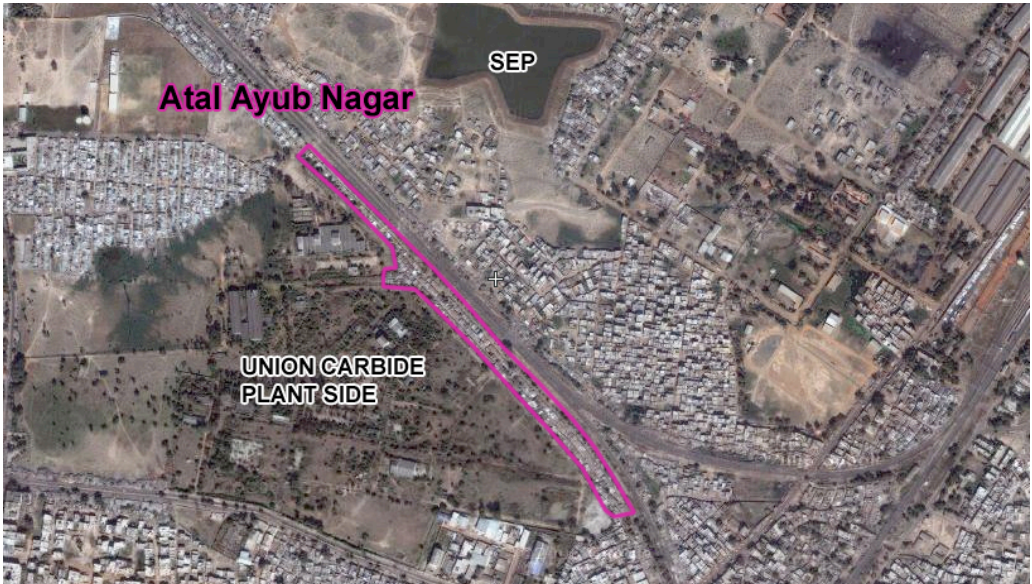
<p>Location</p>

This aerial map illustrates the layout of the Bhopal Gas Tragedy site. The Union Carbide plant is located on the left side, with the 'PLANT SIDE' labeled. To the right of the plant are the 'Atal Ayub Nagar' and 'Shri Ram Nagar' colonies, separated by 'Railway Tracks'. Further to the right are the 'Prem Nagar' and 'Navjeevan Colony'. The 'Kainchi Chola' is located on the far right. A scale bar indicates 200 ft and 50 m, and a compass rose shows North (N), South (S), East (E), and West (W). The area of the colony is noted as 3.55 ha.

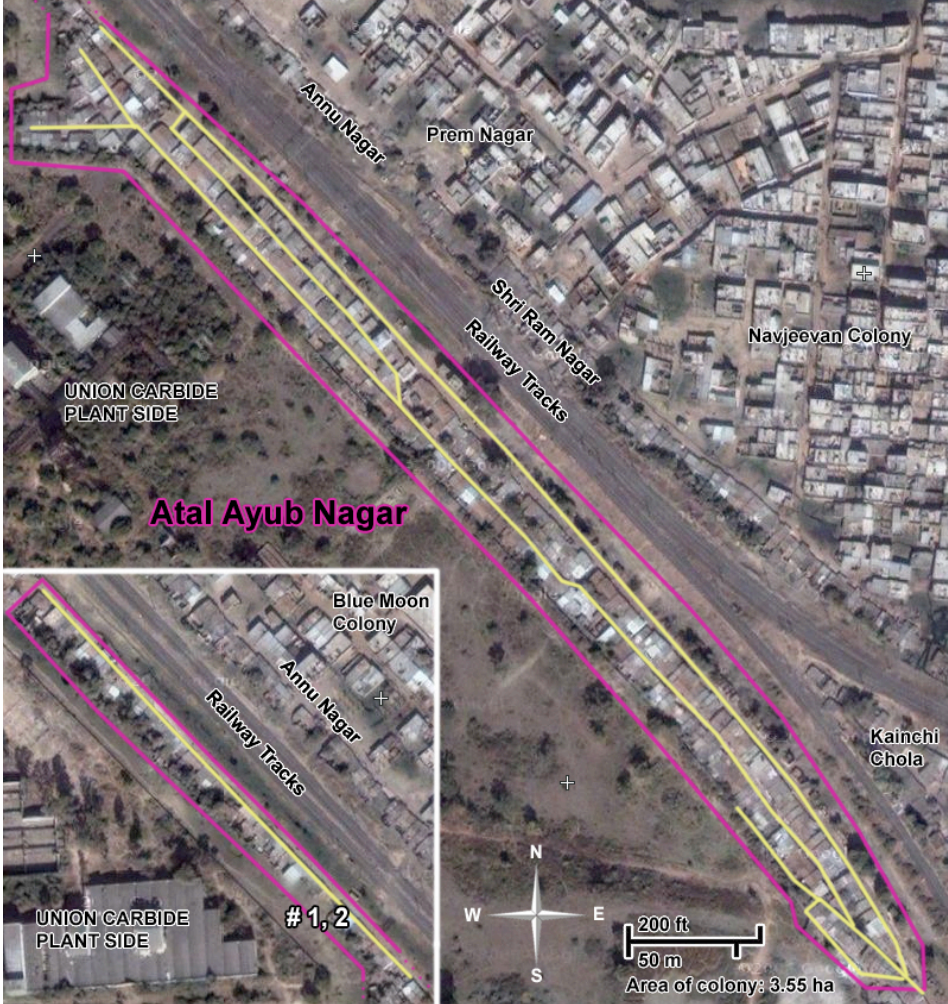
<p>Establishment unknown</p> <p>Inhabitants ~ 1750</p> <p>Area 3.55 ha</p> <p>Location Northeast in the immediate vicinity of UCIL plant side, alongside the railway tracks</p>
<p>Colony Overview</p>

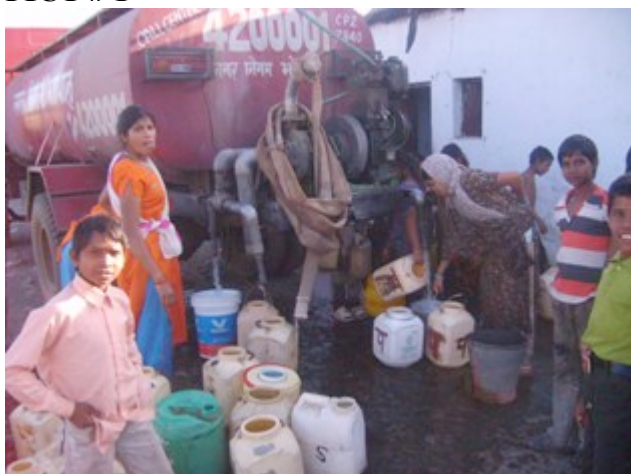
PICT # 1

This tanker truck is in the northern part of Atal Ayub Nagar, where the water tanks are broken.

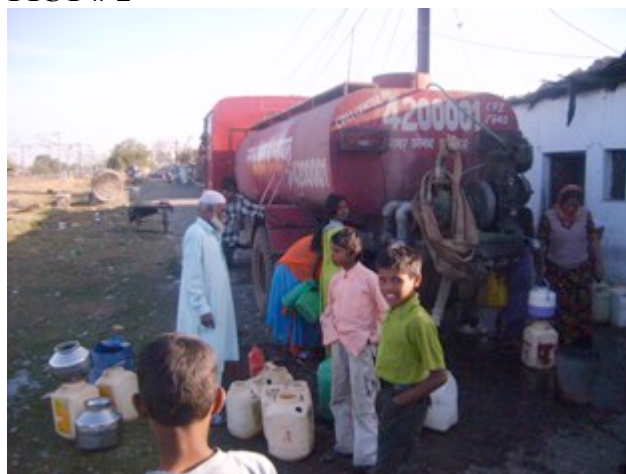
PICT # 2

People draw water directly from the tanker truck because the water tanks in this part of the community are broken.

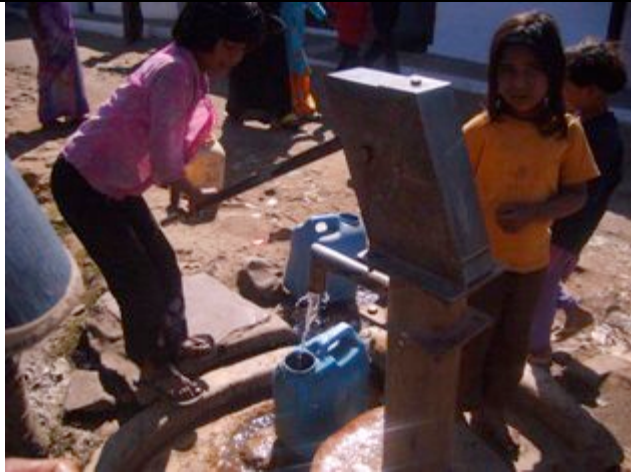
H/P AA 1

Installation 1992	Current status Working and in use
	Depth unknown	
	Water quality Metallic taste, particle matter	
	Water availability Continuous supply	
	Estimated # of people using the source ~ 100 families	
	Water used for drinking? Yes	
Additional information Governmental hand pump. For test results from this pump see Table 3.

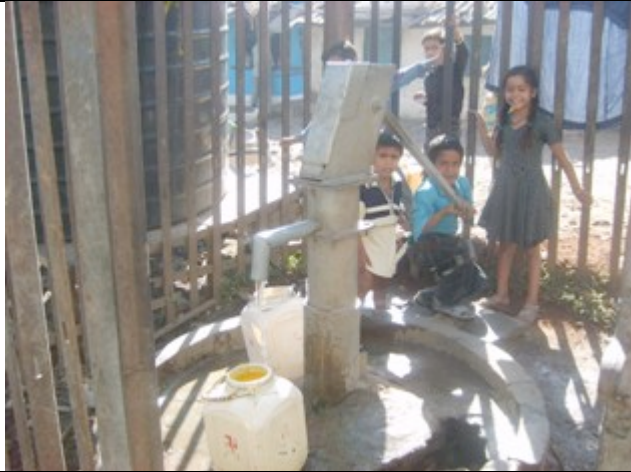
H/P AA 2

Installation 2005	Current status Working and in use
	Depth unknown	
	Water quality Clear and clean, bad smell	
	Water availability Continuous supply	
	Estimated # of people using the source Many people	
	Water used for drinking? Yes	
	Additional information Governmental hand pump.

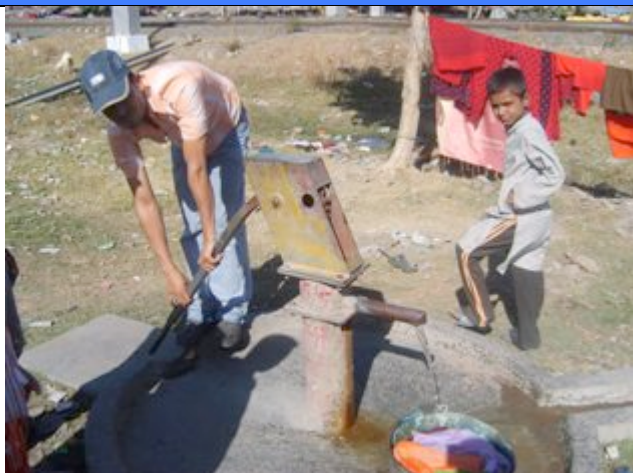
H/P AA 3

Installation 1990	Current status Working and in use
	Depth ~ 120 ft	
	Water quality Poor quality, metallic taste	
	Water availability Continuous supply	
	Estimated # of people using the source ~ 150 families	
	Water used for drinking? Yes	
	Additional information Governmental hand pump.

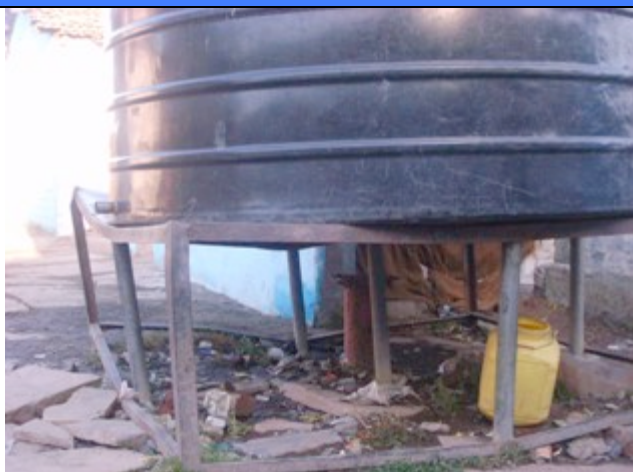
H/P AA 4

Installation unknown	Current status Not working
	Depth unknown	
	Water quality Poor quality	
	Water availability unknown	
	Estimated # of people using the source unknown	
	Water used for drinking? unknown	
Additional information Governmental hand pump. The hand pump was closed down by the municipal corporation in 2003, the reason is not known.

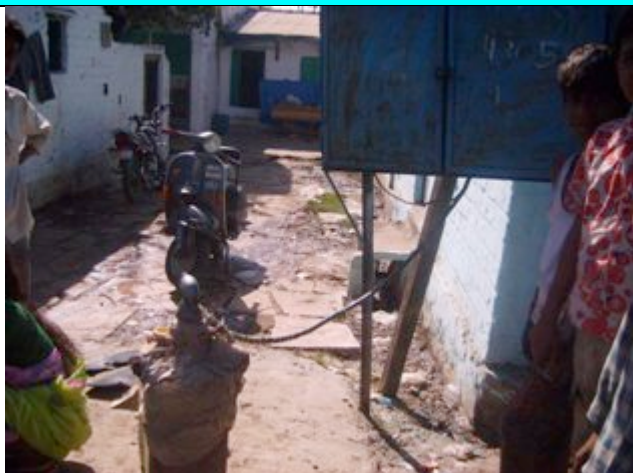
B/W AA 1

Installation 2006	Current status Working and in use
	Depth unknown	
	Water quality Metallic taste	
	Water availability Continuous supply	
	Estimated # of people using the source Many people	
	Water used for drinking? Yes	
Additional information Public mechanical bore well. Bore well was installed by the municipal corporation.

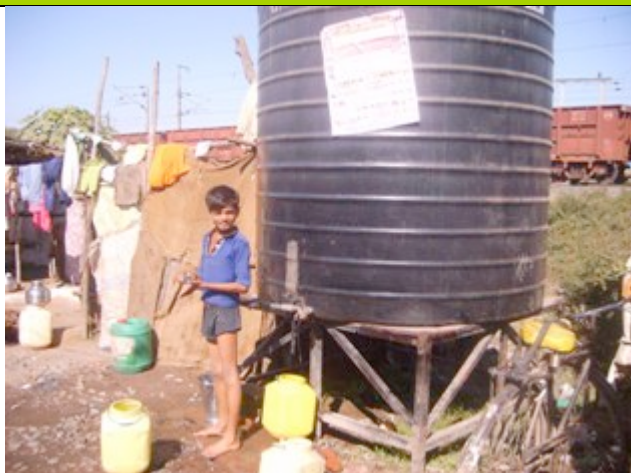
W/T AA 1

Installation 2005	Current status Working and in use
	Depth N/A	
	Water quality Clean and clear, no detectable smell	
	Water availability Scheduled daily refill. Refilled sporadically.	
	Estimated # of people using the source ~ 50 families	
	Water used for drinking? Yes	
	Additional information Plastic tank. Refilled by tanker truck with filtered water from Upper lake.

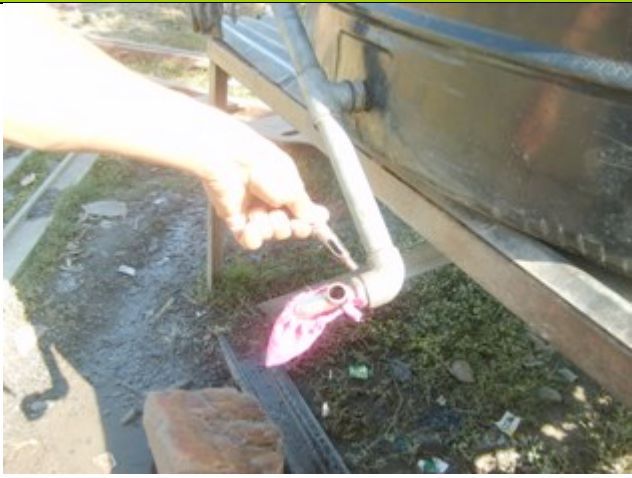
W/T AA 4

Installation 2004	Current status Working and in use
	Depth N/A	
	Water quality unknown	
	Water availability Scheduled daily refill. Refilled sporadically.	
	Estimated # of people using the source Many people	
	Water used for drinking? Yes	
Additional information Plastic tank. Refilled by tanker truck with filtered water from Upper lake. The tank is broken since 2006 and has not yet been repaired by the municipal corporation, despite resident's demands that they do so.

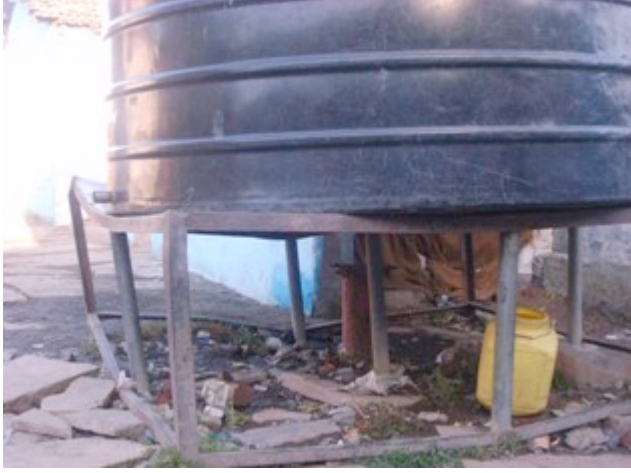
W/T AA 10

Installation	Current status
	2003	Working and in use
	Depth	
	N/A	
	Water quality	
	Sometimes bad quality	
	Water availability	
	Scheduled daily refill. Refilled sporadically.	
	Estimated # of people using the source	
	Many people	
	Water used for drinking?	
	Yes	
Additional information Plastic tank. Refilled by tanker truck with filtered water from Upper lake.
