Learning from Bhopal: Preventing Catastrophic Process Releases

Methyl isocyanate (MIC) release in Bhopal, India

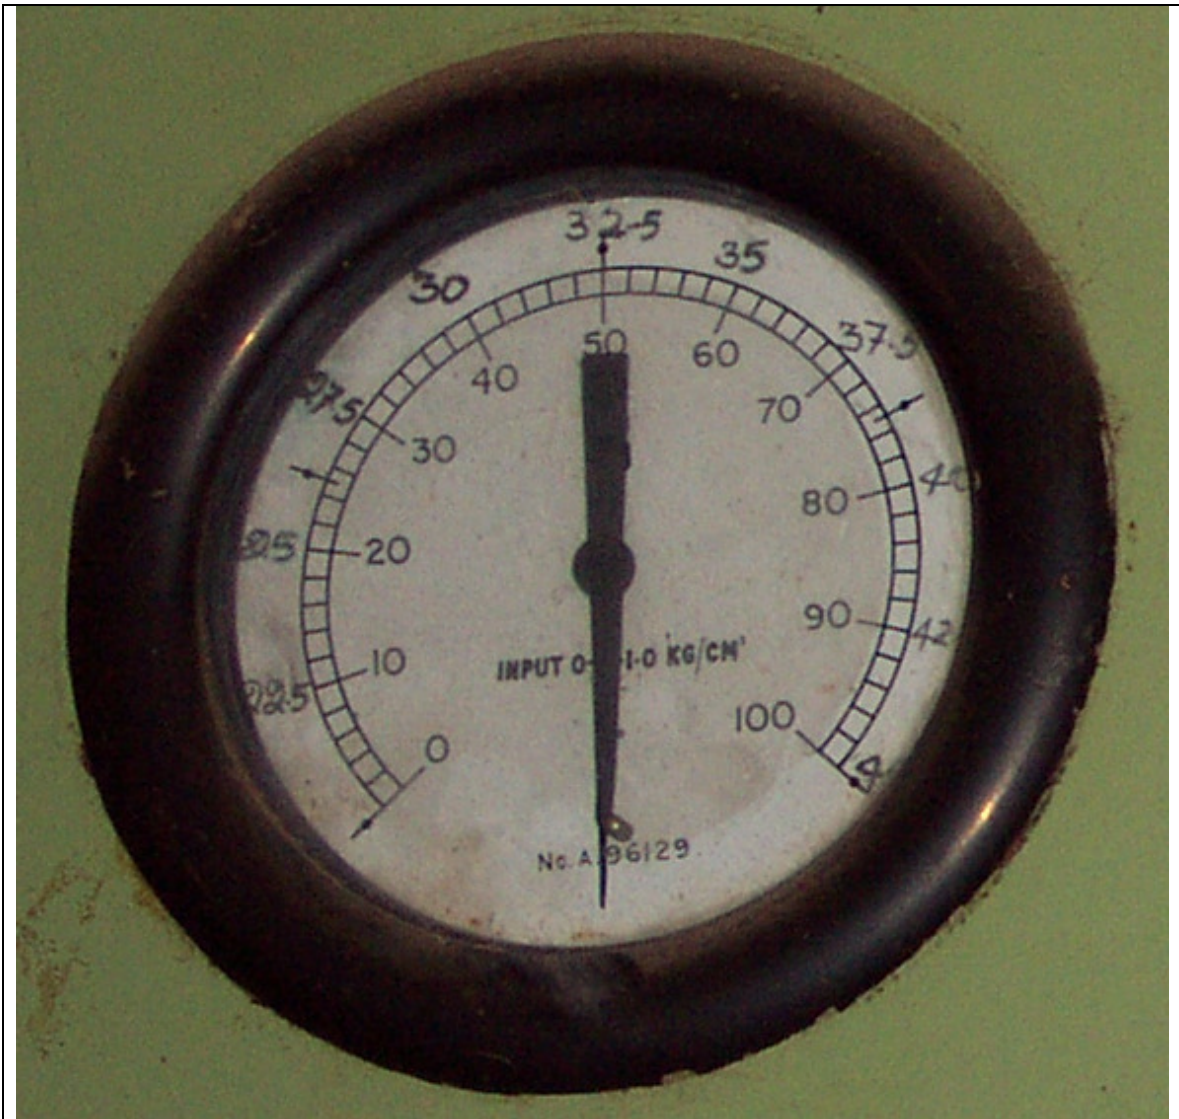
Fig. 1: MIC Storage Tank 610 Control Room Pressure Gauge

Water continued entering the tank until shortly after midnight (December 3, 1984) when the thermal runaway reaction took place. This caused the MIC storage tank's pressure gauge (Fig. 1) to suddenly spike above scale [4]. Although this drew attention to the tank, it was too late to stop the catastrophic loss of process containment.

Tank 610's vent valve was leaking on the evening of December 2, 1984 [61]. This made it impossible to pressurize the tank with nitrogen. However, the pressure inside the MIC storage tank increased as the reaction mixture evolved more vapors into the PVH [62]. Although the control room pressure gauge seemed to be within normal range for a sealed tank [63] the tank was not sealed [64]. Therefore, contamination was not detected until a thermal runaway reaction took place, which sent the tank's pressure soaring above the relief valve setting [65]. Although factory workers responded immediately, by that time it was too late.

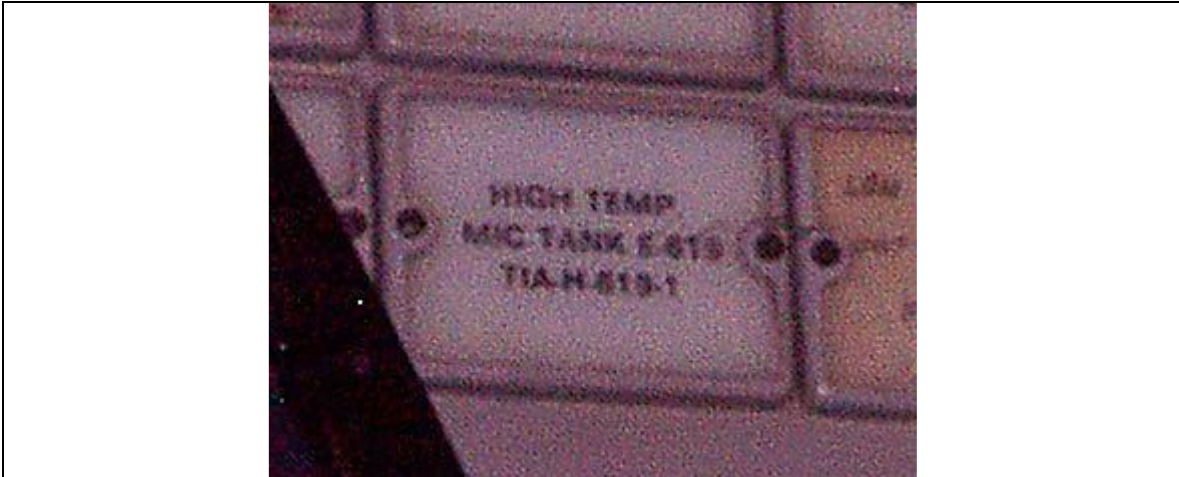
Fig. 7: MIC storage Tank 610 High Temperature Panel Alarm

After shutting down refrigeration system, the MIC storage temperature varied from about 15 °C to 40 °C [43]. This new operating range exceeded the 11 °C MIC Storage Tank high temperature alarm setting (Fig. 7) [44]. Therefore, the high temperature alarms were disconnected [45]. Likewise, the actual temperature inside the tank was unknown [46] after shutting down the refrigeration system because the control room temperature gauge (Fig. 8) was not scaled to operate above +25 °C. Similarly, the normal operating pressure

Somehow, water entered Tank 610 which contained over 40 tons of MIC. Under normal circumstances, this would have activated the tank's high temperature alarm. But the high temperature alarm was disconnected when the refrigeration system was shut down. Likewise, the control room MIC temperature gauge could not be trusted because it normally read above scale without refrigeration. The refrigeration system was shut down almost three years before the incident [60] to manage the potential hazards resulting from pump seal failures. The contamination event inside Tank 610 remained hidden while the reaction mixture continued warming up.
